**HC MUD 148**  
**INITIAL REPORT**  
**Greenbrook Place**

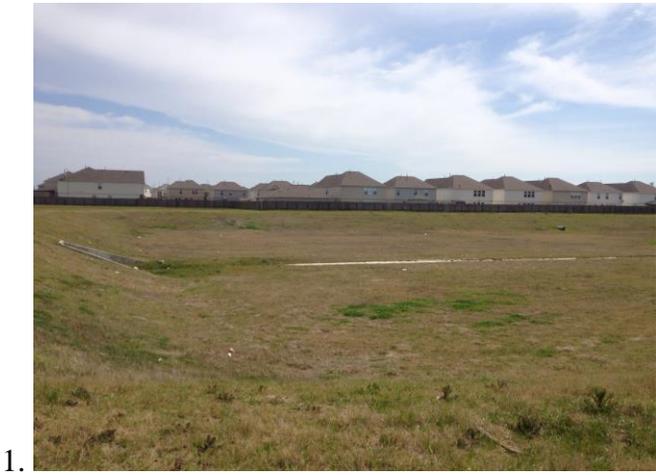
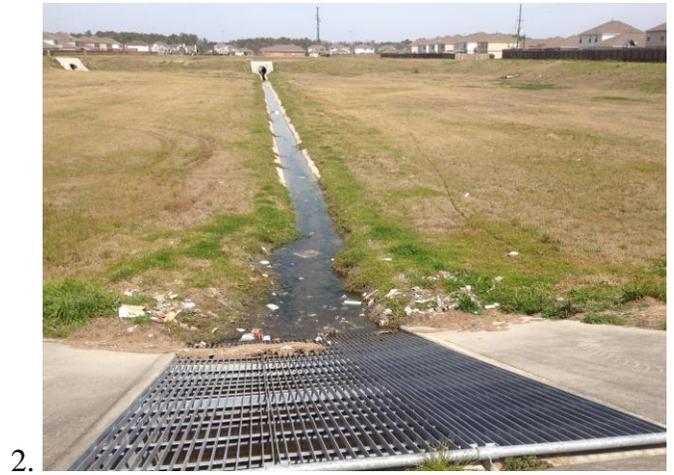
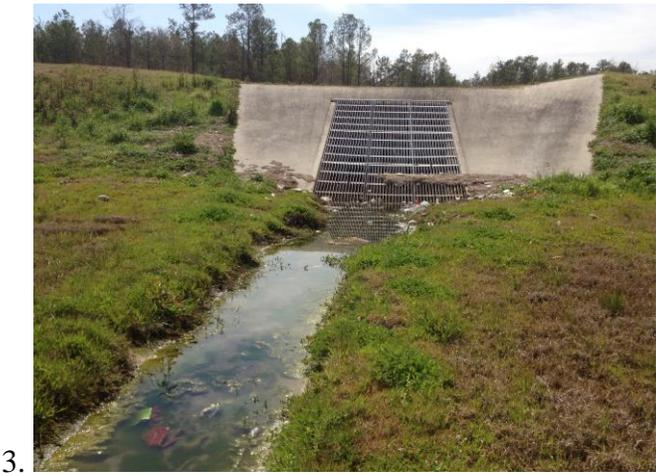
After reviewing the two ponds in Greensbrook Place, I would say that they are in relatively good shape. However, there are a few things that should be addressed. First, is a need for debris cleanup scattered along both of these ponds (Photo 1 - 3). This is important to protect the Storm Water Quality Feature on the South pond that flows into the nearby bayou. Second, I notice one area that could potentially be a sinkhole (Photo 4). It appears someone has tried to fill this void, yet if not repaired from the inside out, it could grow overtime. This could also be a liability to the district if injury arises to those who walk along the pond.

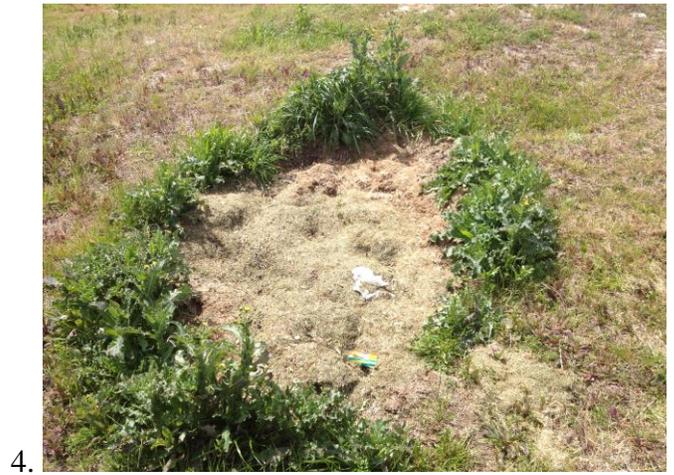
Both ponds have minor damage to the side slopes as a result of being mowed while wet (Photos 5 & 6). If this pattern were to continue the slopes would lose a significant amount of stability and silt into the bottom of the pond. There are multiple areas that will significantly benefit from a spring/ fall overseed and fertilization, including a large area of weeds that has choked out the grass. (Green patches in photo 7). These applications should also help repair the side slope damage.

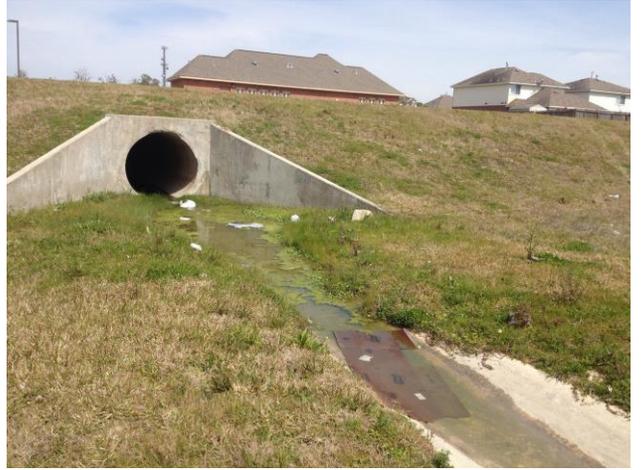
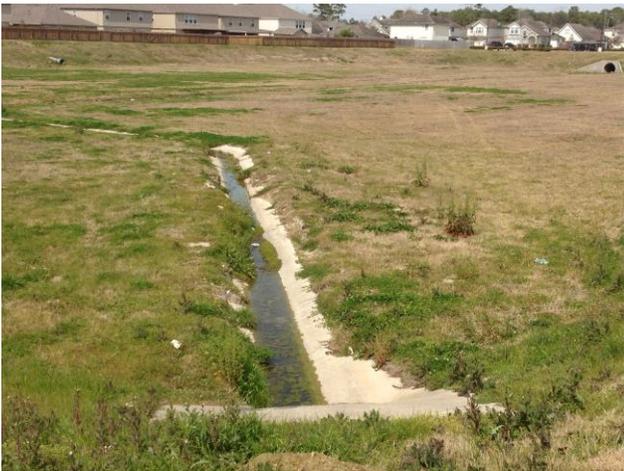
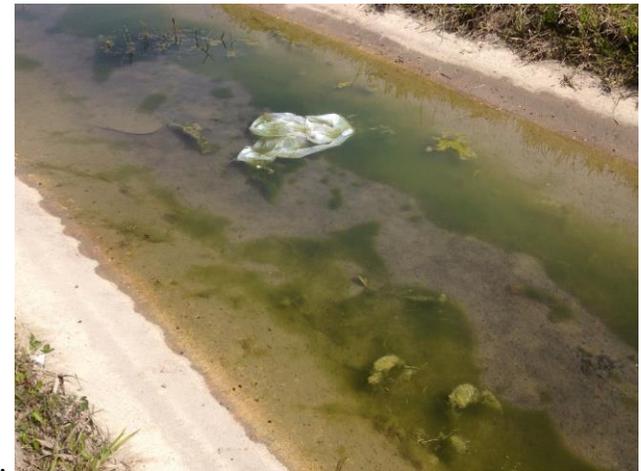
Additionally, there is some silt build up in several areas of the pilot channels (Photos 8 - 10). While this is not a pressing issue, I would advise some action be taken no later than December (2013) to ensure it remains a nominal repair.
